COMPDYN 2013
4th ECCOMAS Thematic Conference on
Computational Methods in Structural Dynamics and Earthquake Engineering
M. Papadrakakis, V. Papadopoulos, V. Plevris (eds.)
Kos Island, Greece, 12–14 June 2013

THE EMILIA EARTHQUAKES: REPORT AND ANALYSIS ON THE BEHAVIOR OF PRECAST INDUSTRIAL BUILDINGS FROM A FIELD MISSION

Dionysios A. Bournas¹, Paolo Negro², and Fabio Taucer²

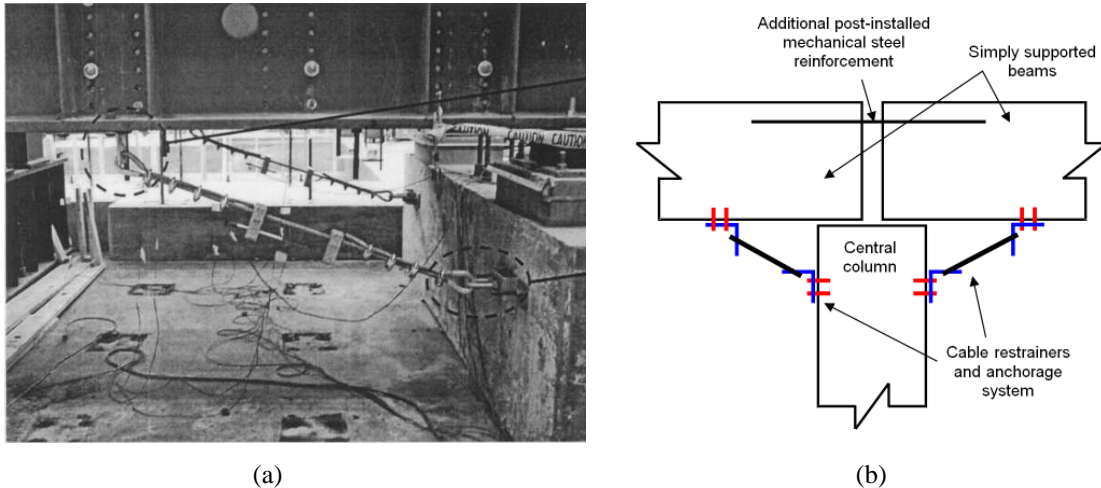
Figure 10: (a) Side view of a full-scale bridge model with seismic cable restrainers (DesRoches et al. 2003); (b) General concept of a retrofit solution for industrial buildings with beams simply supported on the column top comprising seismic cable restrainers and possibly additional steel reinforcement.

A proposal for the strengthening of existing industrial building consists in adopting a scheme which is used for the seismic retrofit of simply supported bridges: to reduce the likelihood of collapse due to unseating, cable restrainers are used between the girders and the piers/abutments of the bridge. Cable restrainers were first used in the United States after the collapse of several multi-frame bridges that collapsed due to unseating during the 1971 San Fernando earthquake in California [12]. The performance of bridges in the 1989 Loma Prieta and 1994 Northridge earthquakes showed that cable restrainers were effective in limiting damage [13-15]. DesRoches et al. 2003 [16] evaluated the force-displacement behavior of a cable restrainer assembly, used for the seismic retrofit of simply supported bridges. The cable restrainers were connected to the bridge pier using steel bent plates, angles, and undercut anchors embedded in the concrete as specified by typical bridge retrofit plans. The test results demonstrated that this strengthening configuration was effective in cases where seat widths were very small and relative displacements needed to be limited. The results of this study might form a good basis for future research on the use of cable restrainers for the retrofit of industrial buildings with beams simply supported at the top of columns (Fig. 10). The restrainers in such a system would be anchored at the column and beam ends, where the bending moment is minimum, with the advantage that their installation would not significantly disturb the functioning of the building.

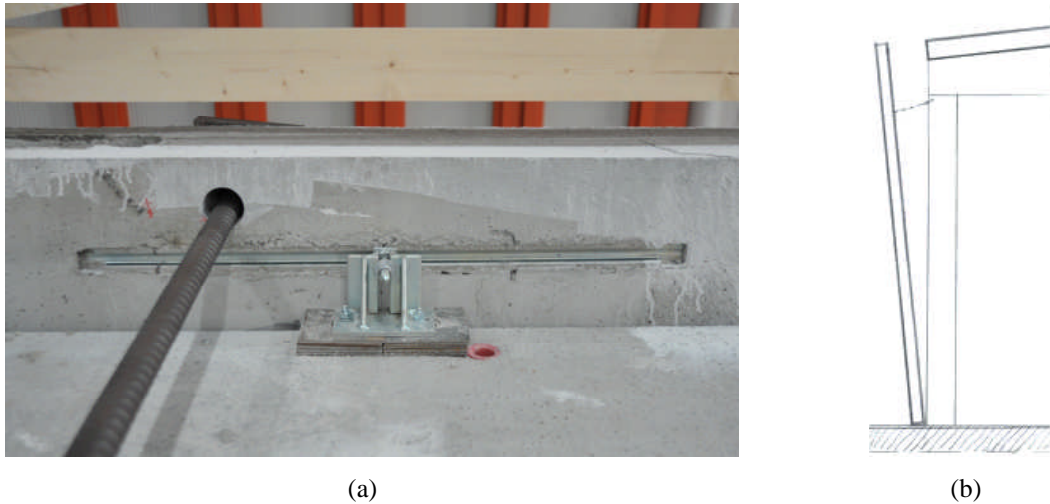
Figure 11: (a) Panel connection device that provides resistance in the vertical and out-of-plane directions and accommodates large relative deformations in the lateral direction. (b) Fail-safe restraints to prevent panel falling.

tribute to seismic response, stringent design criteria for the design of the connections should be enforced: connections devices should be able to provide the required strength in the vertical and out-of-plane directions while accommodating large relative deformations in all other directions (Figure 11a). A viable option would be to prescribe adequate fail-safe restraints, so that the panels would not fall even in case the relative displacement capacity of the connection is exceeded (Figure 11b). Another possibility would be to design the claddings and their connections as being an integral part of the structure, by adequately taking into account their strength and stiffness in the design model. These are the objectives of the recently activated EU-funded project SAFECLADDING (Grant Agreement no. 314122).
